## **New Hartford**

Main Street (Route 44) Corridor – New Hartford Center – Road Safety Audit November 16, 2016

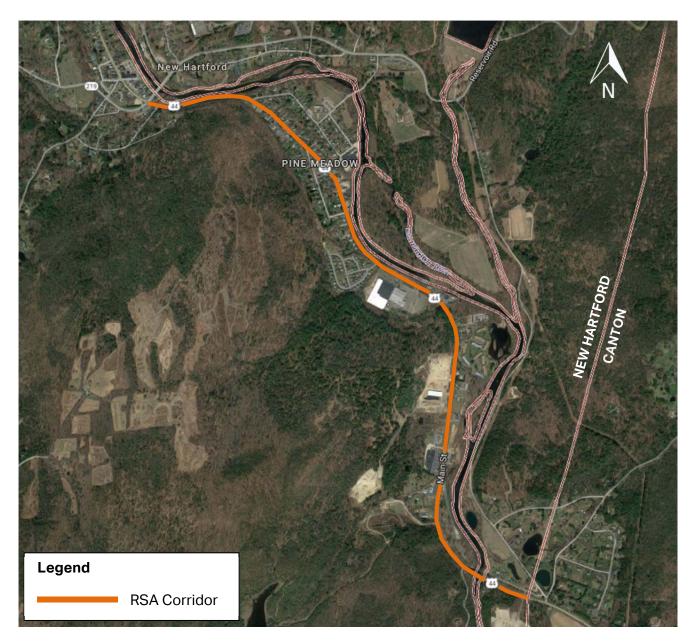
Figure 1. Main Street (Route 44), New Hartford

The RSA site is the section of Main Street (Route 44) between Reservoir Road (Route 219) to the north-west and the Breezy Hill Road to the south-east (Figure 1). Figure 2 shows the study corridor in a regional context. Main Street (Route 44) has a functional classification of Principal Arterial. It is an east-west U.S. highway that runs from the New York state line in Salisbury to the Rhode Island state line in Putnam. In New Hartford, Route 44 runs generally in a northwest-southeast direction through the study area. The Average Daily Traffic (ADT) on Route 44 near Breezy Hill Road is 11,600 vehicles per day (vpd) and near Reservoir Road

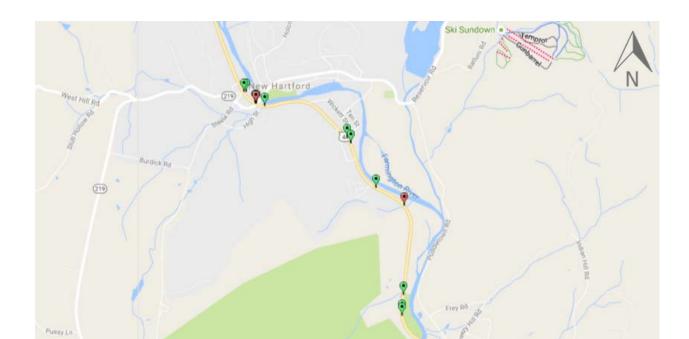
Figure 3. Crashes that Occurred in 2015 (Connecticut Crash Data Repository)

Figure 3 displays crashes that occurred in this area during 2015. As shown in the figure, they are evenly distributed in the study area, with four clustered along Main Street from Reservoir Road to High Street. All the crashes resulted in property damage only except for two, which resulted in injury.

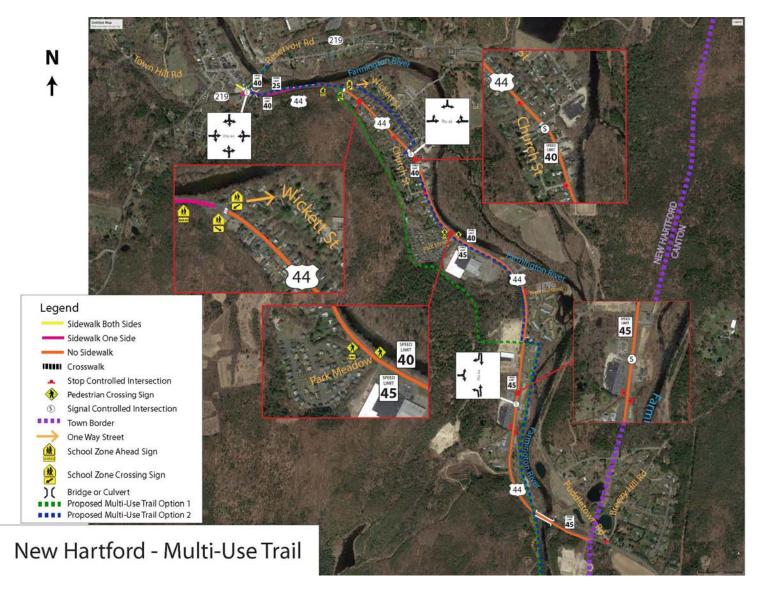
Figure 4. Route 44 Road Geometrics

Route 44 consists of a single lane in each direction, separated by a double yellow center line. Turn lanes are provided at the Foothills Shopping Plaza intersection. The lanes from Reservoir Road to Wickett Street (north) are 12 feet wide in each direction, and vary from 11 to 13 feet wide in each direction from Wickett Street (north) to Breezy Hill Road. There are striped shoulders on both sides that vary from three to six and a half feet wide in the northbound direction and from two to eight feet wide in the southbound direction. Bituminous curb is provided throughout most of the study corridor, although the section on the structure south of Reservoir Road has concrete curb with low reveal. Some sections of the corridor do not have curbs and in some sections the curbs are very low and are overgrown with grass.

Figure 4 and Table 3 below show the roadway geometrics for the Main Street (Route 44) corridor.

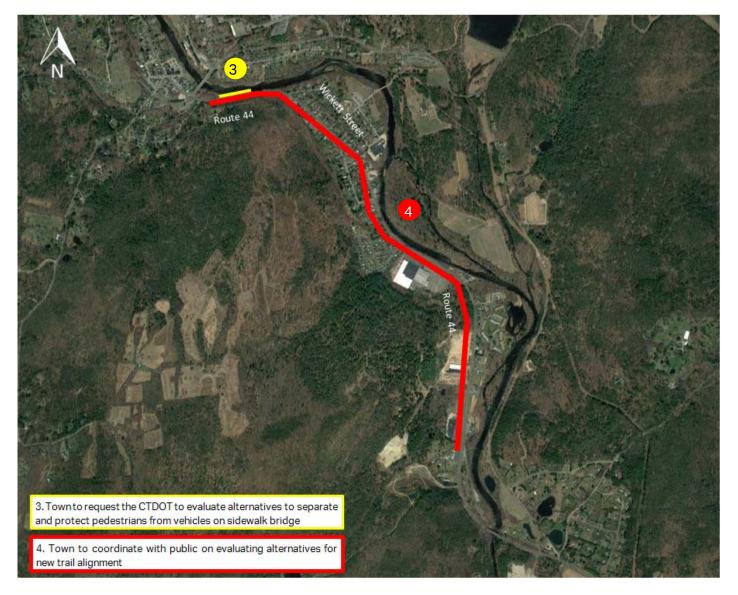
**Figure 24: Short-Term Recommendations**

- 1. Town to coordinate with CTDOT for VIP repaving schedule for Route 44. Town to coordinate with CTDOT to restripe the lanes on Route 44 to 11 feet wide when repaved.
- 2. Town to investigate viable parking options for people who want to fish from the bridge.
- 3. Town to coordinate with CTDOT to evaluate alternatives to separate and protect pedestrians from vehicles on the sidewalk of the bridge. Alternatives to evaluate should include rumble strips, barrier and high curb reveal. Lighting improvements should be investigated (Figure 23).
- 4. Town to continue coordinating with residents and Figure 23: Shoulder rumble strips local business owners to evaluate alternatives, identify the most feasible and beneficial alignment for a new trail, and work towards gaining consensus.

Figure 24 depicts these recommendations.

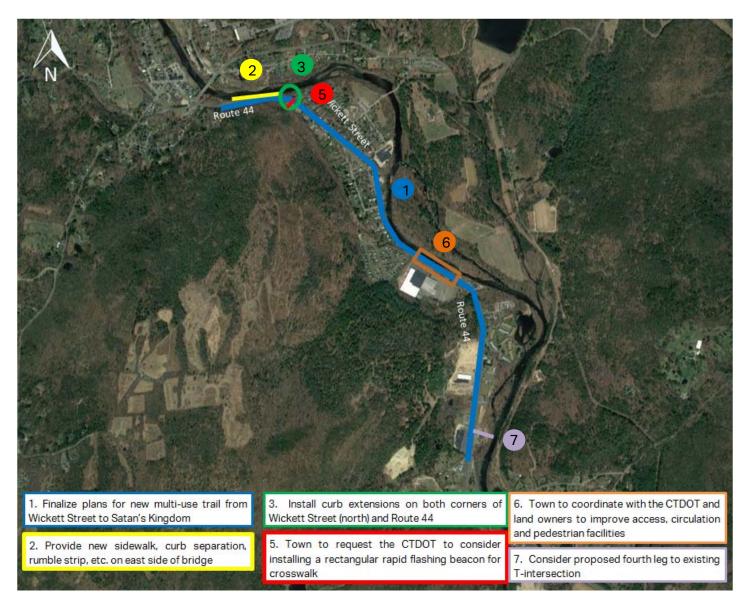
Figure 26: Medium-Term Recommendations

- 8. Town to coordinate with land owners adjacent to the proposed trail alignment along Route 44 to identify potential constraints and solutions. One potential location is the monument sign for River Run condominiums on the east side of Route 44.

Figure 26 depicts these recommendations.

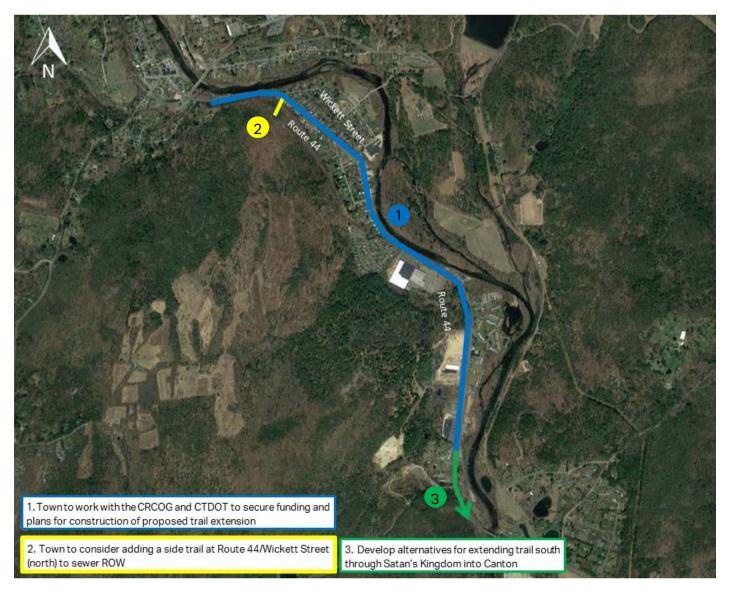
**Figure 27: Long-Term Recommendations**

- 1. Town to coordinate with CRCOG and CTDOT to secure funding and plans for construction of the proposed trail extension.
- 2. Town to consider adding a side trail at Route 44/Wickett Street (north) that would connect to the sewer ROW on the west side of Route 44. This would provide a scenic view for users.
- 3. Town to coordinate with CRCOG, DEEP, and Canton to develop alternatives for extending the trail south through Satan's Kingdom into Canton.
- 4. Town to coordinate with CTDOT to reset curb along Route 44 to standard reveal height when Route 44 is repayed as part of the VIP program.

Figure 27 depicts some of these recommendations.
